**CH-21A HELICOPTER AIRFRAME DEFORMATION
UNDER A DYNAMIC CRASH CONDITION**

Pertaining to the Dynamic Crash Test of a U. S. Army CH-21A Helicopter

TRECOM Technical Report 63-77

Technical Report
AvSER 63-3

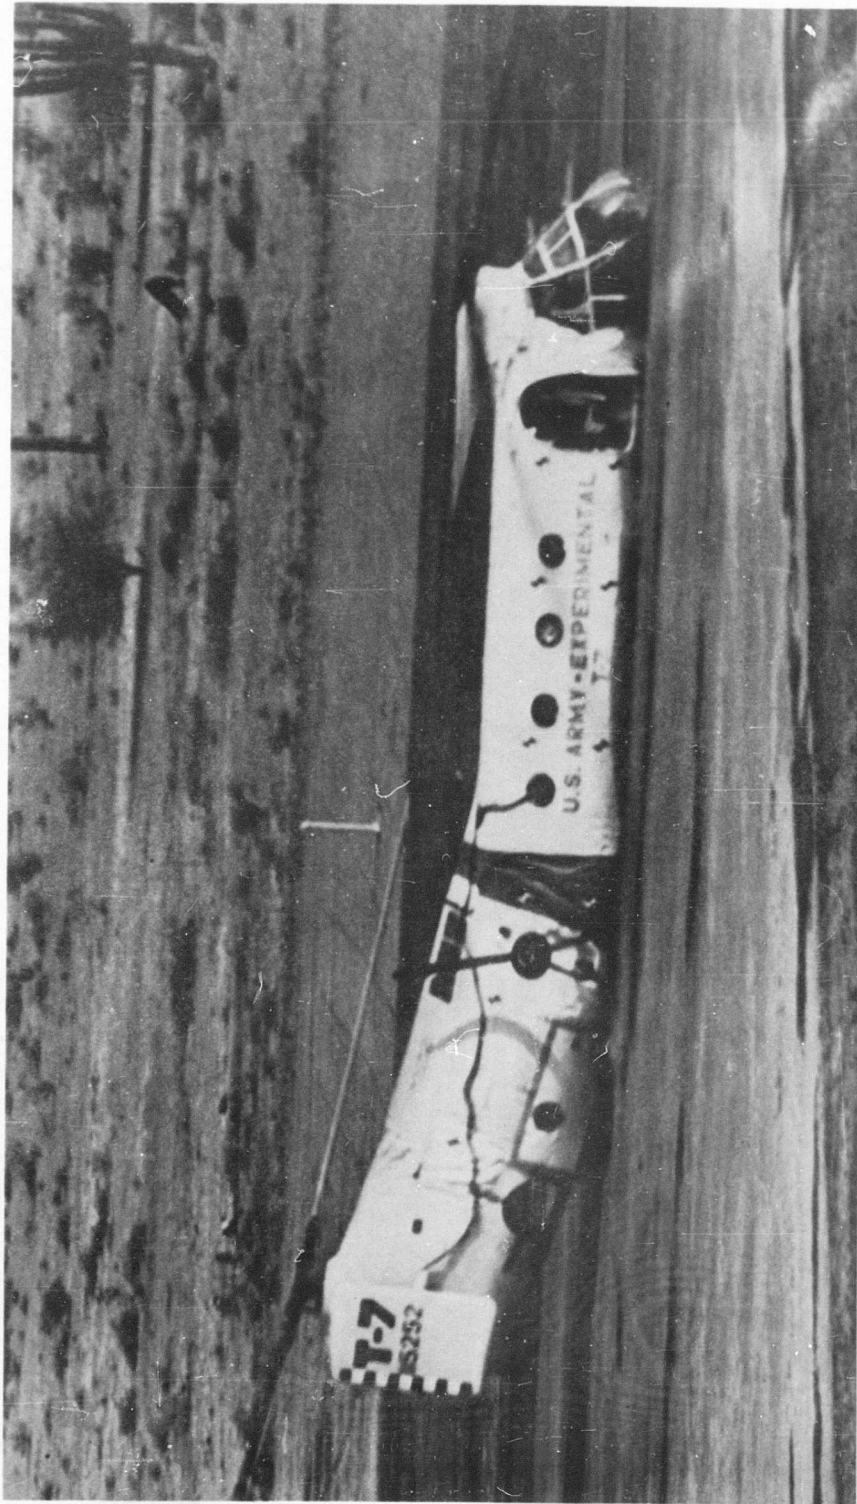
Figure 5. Test Vehicle 0.240 Second After Initial Impact.

Notice that the landing gear have failed, and that the lower fuselage is crushing due to impact. Also, notice the skin wrinkles in the dark band just forward of the main landing gear and in the tail section just above the engine compartment access door as well as the skin wrinkles below the forward rotor between the door and the cockpit. (U.S. Army Photograph)

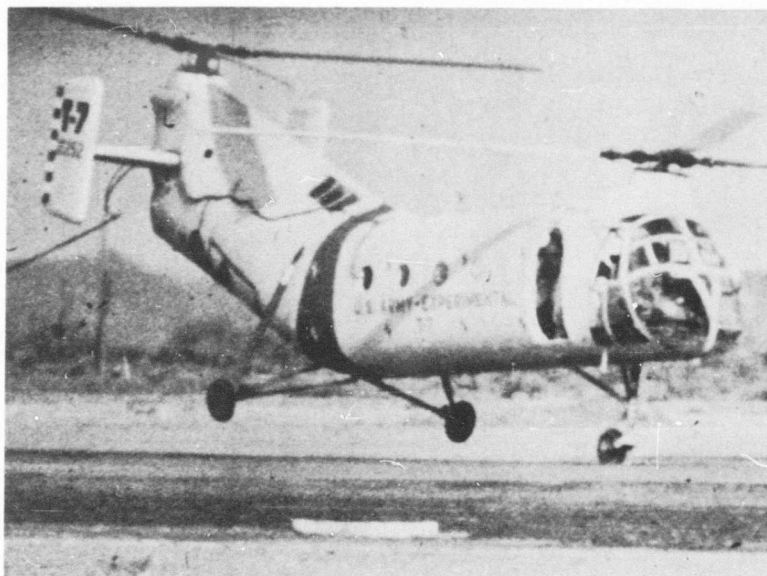
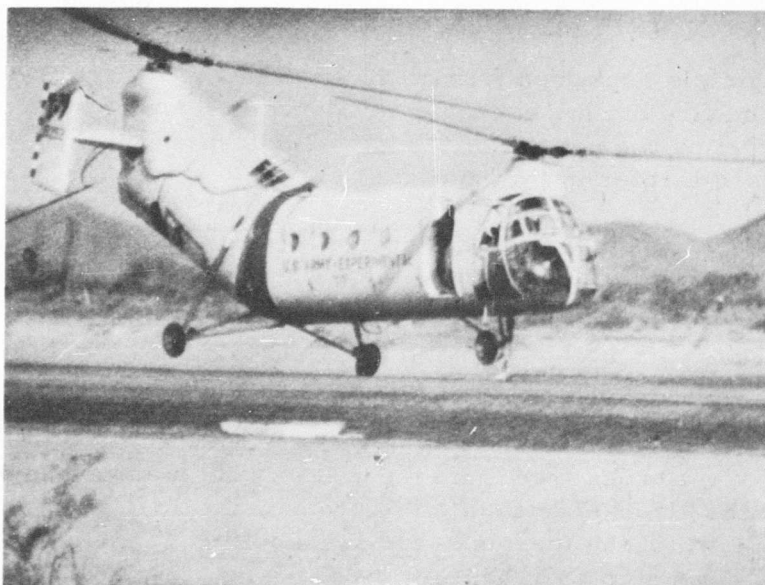
The nose wheel broke away from the oleo strut, and then the nose landing gear oleo strut broke free from the aircraft at its attachment to the fuselage. As the aircraft settled to the ground, the nose wheel bounced up into the bottom of the fuselage, and the oleo strut assembly folded aft so that both were trapped beneath the forward section of the cargo compartment (Figures 9, 10, and 11).

Figure 9. Sequence Photo of Nose Landing Gear Failure.

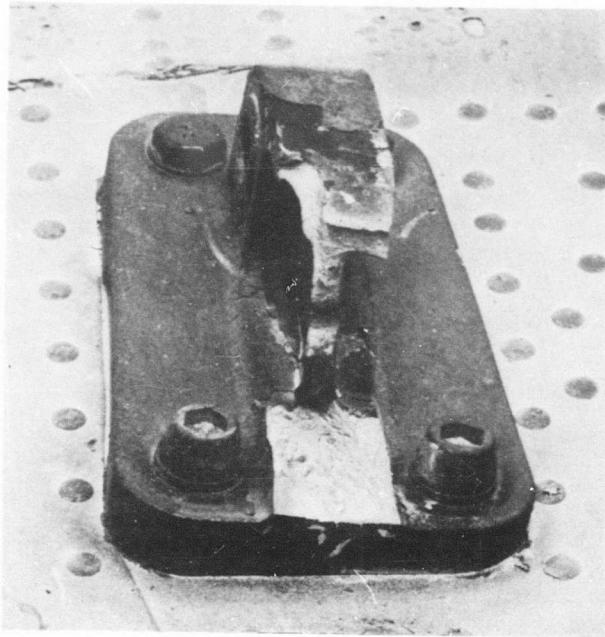
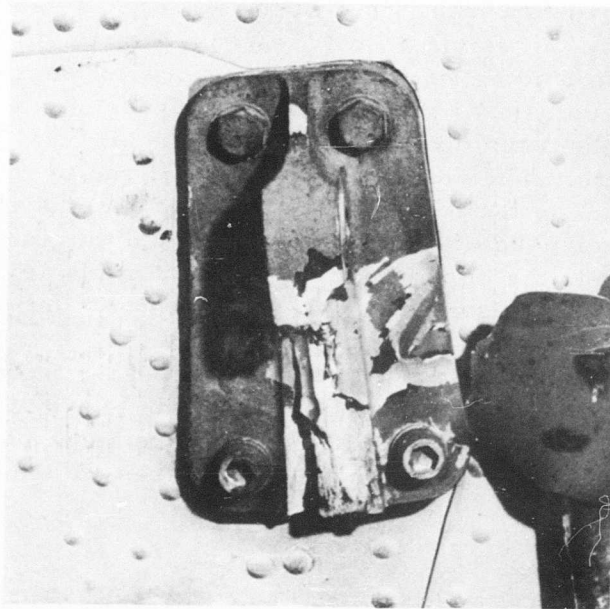
Both main landing gear support fittings, parts numbers 4251048-1 left side and 4251048-2 right side, failed (Figures 12 and 13). Study of high-speed motion picture film revealed that prior to the fitting failure, the main landing gear oleo struts were not compressed any appreciable amount; they acted as solid compression members. Impact forces were transmitted directly to the support fittings, causing their immediate failure. The oleo struts were then free to rotate about their lower attach point as the fuselage continued downward toward impact. The upper ends glanced off the fuselage skin and moved upward and outward relative to the support fittings without doing any major damage to the fuselage structure.

Figure 12. Main Landing Gear Support Fitting, Right Side.

Figure 13. Main Landing Gear Support Fitting, Left Side.

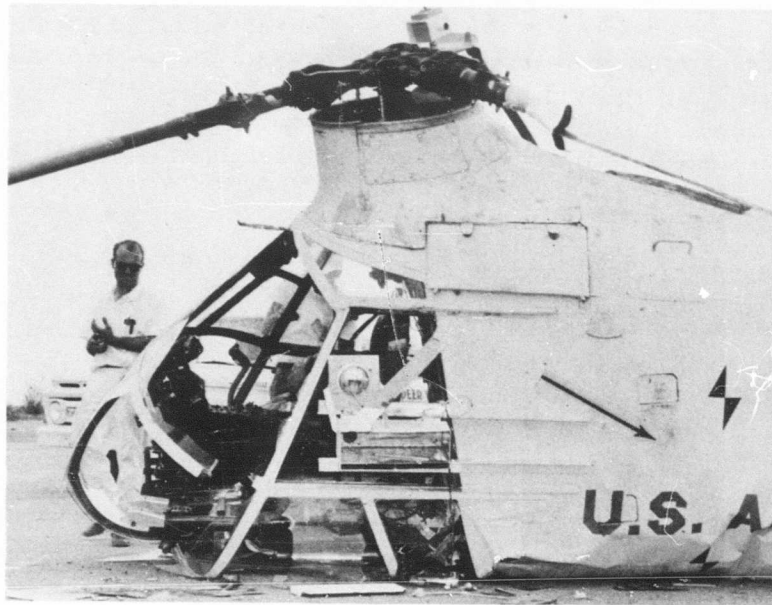
The bulkhead behind the pilot's seat, fuselage station 97.036, partially collapsed due to the high compressive load imposed upon it by the forward rotor transmission. The partial failure of this bulkhead allowed the transmission and rotor head to move downward and forward, causing collapse of the cockpit window frame structure, which then struck the instrument console (Figure 16). All the cockpit windows were broken. The partial failure of the station 97.036 bulkhead also resulted in buckling of fuselage skin aft of this station (Figure 17).

Figure 17. Left Side of Cockpit Following Crash. Notice the deformation of window frame structure and the skin wrinkles aft of the cockpit (arrow).

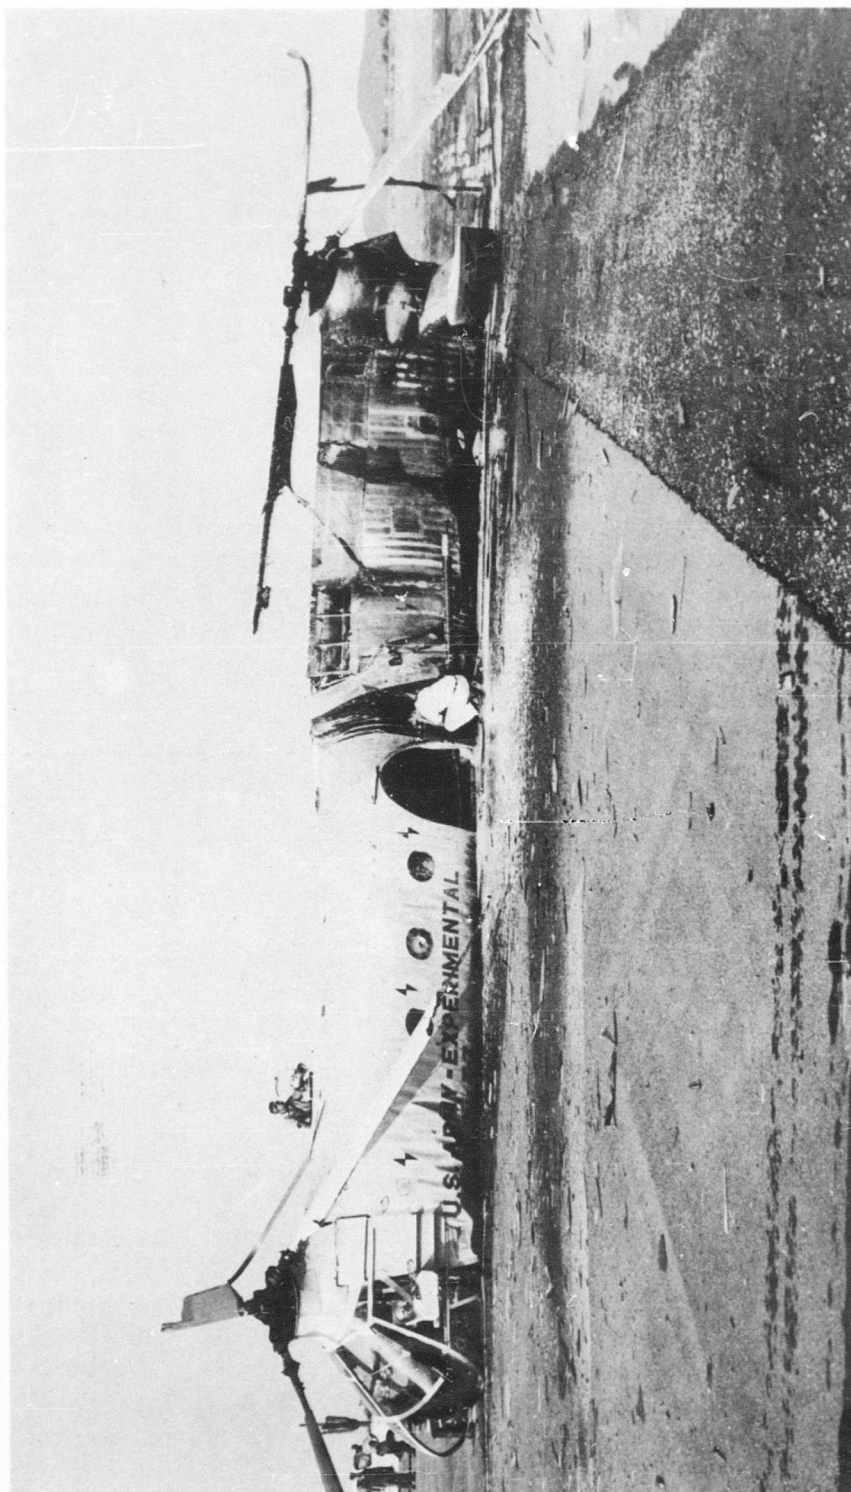
Figure 18. Overall View of Left Side of Aircraft Wreckage.

The entire cargo compartment lower body, including fuselage skin, floor support structure, and lower sections of body frames, was crushed by impact. Because the aircraft impacted with a slight left roll (Figure 4), the lower fuselage sustained more damage on the left side than on the right side.

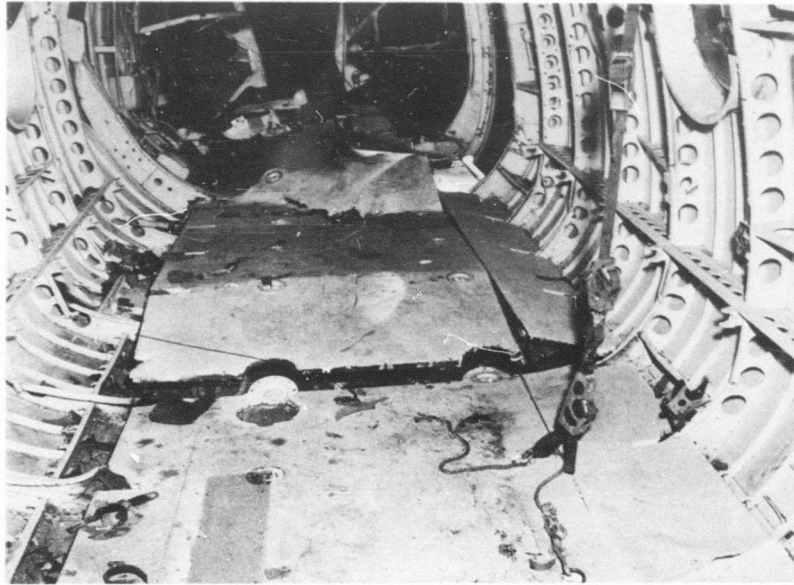
Figure 20. Overall View of Passenger Compartment Floor. This view is toward front of aircraft, after removal of experimental equipment.

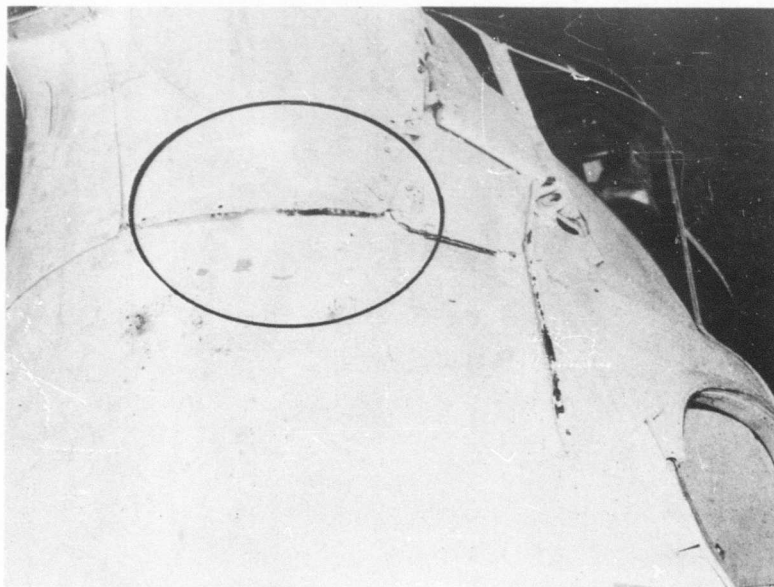
The forward displacement of the forward rotor transmission and rotor head assembly caused the failure of a row of fasteners at the junction of the fuselage station 119.50 bulkhead and the upper fuselage skin at the aft edge of the right side cowling assembly, part number 2258020-7. The tearout of this row of fasteners progressed outboard into a tear of the fuselage skin panel immediately outboard of the cowling assembly. The upper fuselage skin aft of the fastener failure was buckled due to the tensile load which was applied by the forward displacement of the rotor head.

Figure 22. Upper Fuselage Aft of Forward Rotor Head.
This photograph shows the separation of the cowling and the skin panel on the upper fuselage skin aft of the forward rotor head, fuselage station 119.50.

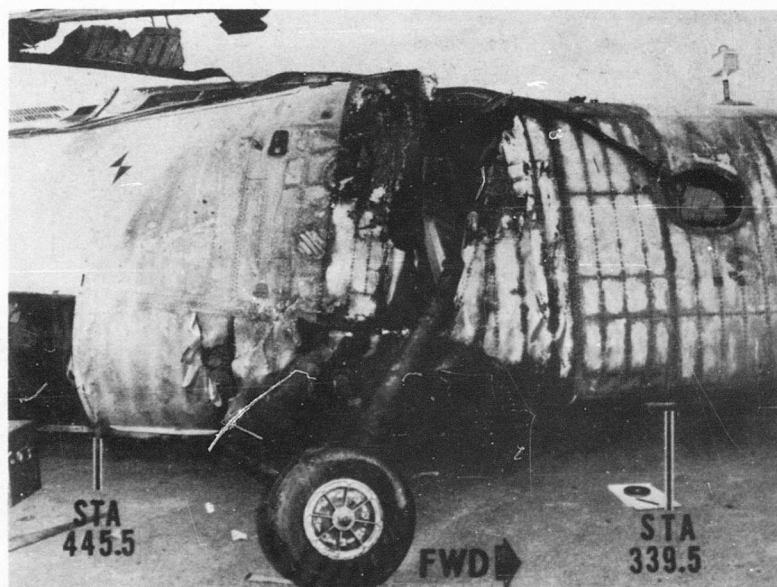
When the aircraft contacted the runway, the aft fuselage section bent downward. The deflection was of such magnitude that the fuselage straightened out and the bottom surfaces of both the forward fuselage section and the aft fuselage section were in contact with the runway simultaneously. This bending of the fuselage resulted in failure of the fuselage structure and rupture of the fuselage skin between fuselage station 360 and fuselage station 407, just forward of the main landing gear.

The break in the fuselage extended from beneath the fuel tank on the bottom of the aircraft, up the right side, and over the top of the aircraft. The fuselage structure beneath the fuel tank and plenum chamber was badly mangled by a combination of impact, sliding, and puncturing by the main landing gear V-brace assemblies. The V-braces punctured the fuselage on both sides of the aircraft.

Figure 23. Fuselage Failure, Right Side.
